Flood Control Project Maintenance
2014 Structure Summary Report
Overall Unit and Item Ratings

Reclamation District No. 2063 Crows Landing

Lateral No. 6 Pumping Plant

Flood Control Project Maintenance**Unit Cover Sheet****2014 Pumping Plant Inspection Results****Reclamation District No. 2063 Crows Landing**

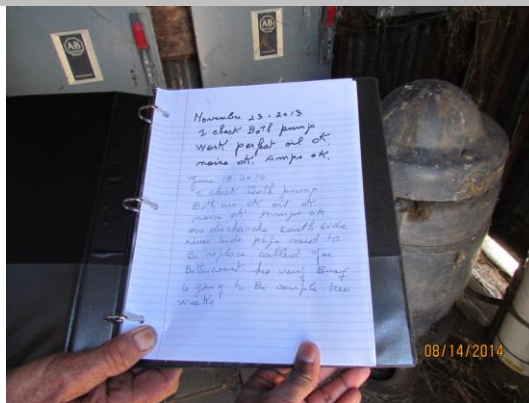
Photo 1 of 1 : ST_2014_RD2063_53_1_20140819_00010.jpg

LM Start	0.00	Rating **	A	Issue No.	1	
LM End	0.00	Issue Type +	Ma	Location *		
Category	Pump Stations			GPS Latitude/Longitude		
				Start	End	
Item	Operating Log			37.397931 °	37.397931 °	
				-120.972176 °	-120.972176 °	
DWR ID	DWR_RD2063_53_t_2012_1					
Action/Comments						
Inspector Comments: Operation log was completed and up to date.

View of the operation log.

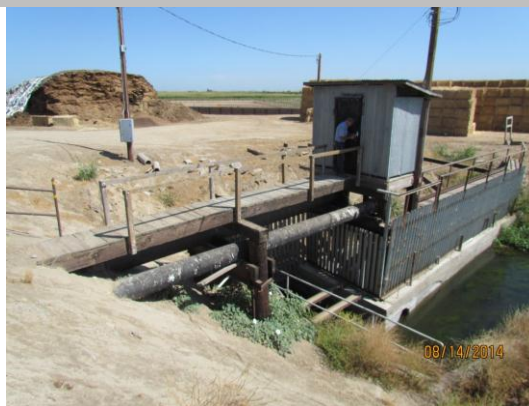
Photo 1 of 1 : ST_2014_RD2063_53_4_20140819_00011.jpg

LM Start	0.00	Rating **	A	Issue No.	4
LM End	0.00	Issue Type +	Ma	Location *	
Category	Pump Stations			GPS Latitude/Longitude	
				Start	End
Item	Plant Building			37.397931 °	37.397931 °
				-120.972176 °	-120.972176 °
DWR ID	DWR_RD2063_53_t_2012_4				
Action/Comments					
Inspector Comments: The plant building appeared to be in a good structural condition.

View of the pumping plant.

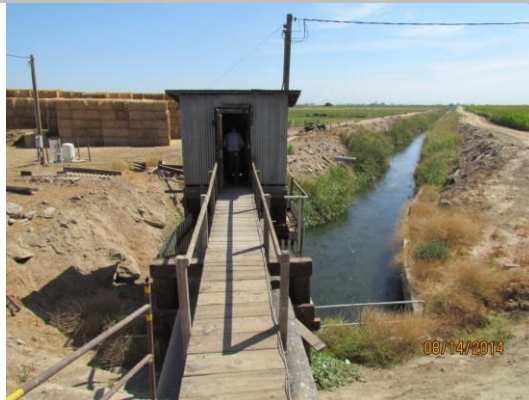
Photo 1 of 1 : ST_2014_RD2063_53_6_20140819_00012.jpg

LM Start	0.00	Rating **	A	Issue No.	6
LM End	0.00	Issue Type +	Ma	Location *	
Category	Pump Stations			GPS Latitude/Longitude	
				Start	End
Item	Safety			37.397931 °	37.397931 °
				-120.972176 °	-120.972176 °
DWR ID	DWR_RD2063_53_t_2012_6				
Action/Comments					
Inspector Comments: There was not any significant safety hazard present outside of the pumping plant during inspection and the handrails prevented failing hazards around the pumping plant.

View of the handrails.

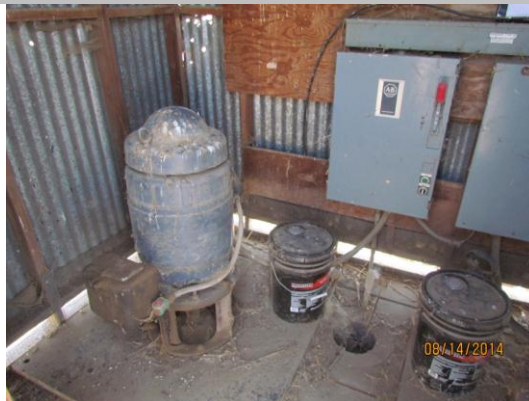
Photo 1 of 2 : ST_2014_RD2063_53_7_20140819_00013.jpg

LM Start	0.00	Rating **	A	Issue No.	7	
LM End	0.00	Issue Type +	Ma	Location *		
Category	Pump Stations			GPS Latitude/Longitude		
				Start		End
Item	Pumps			37.397931 °	37.397931 °	
				-120.972176 °	-120.972176 °	
DWR ID	DWR_RD2063_53_t_2013_7					
Action/Comments						
Inspector Comments: Pumps were fully operational and they were turned on during the inspection.

View of one of the pumps inside the pumping plant.

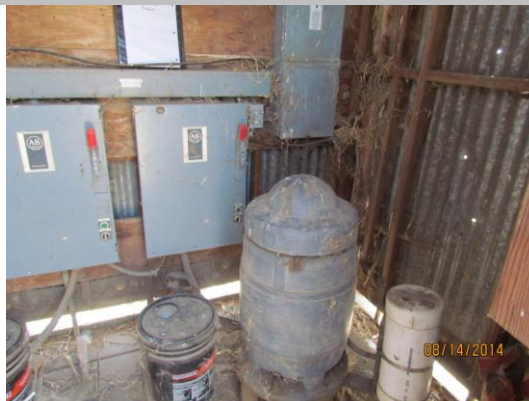
Photo 2 of 2 : ST_2014_RD2063_53_7_20140819_00014.jpg

View of another pump inside the pumping plant.

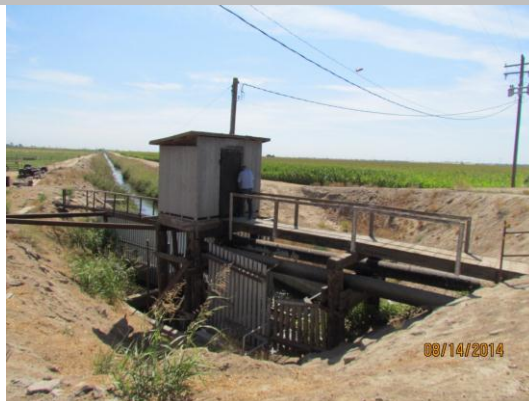
Photo 1 of 1 : ST_2014_RD2063_53_9_20140819_00015.jpg

LM Start	0.00	Rating **	A	Issue No.	9
LM End	0.00	Issue Type +	Ma	Location *	
Category	Pump Stations			GPS Latitude/Longitude	
				Start	End
Item	Power			37.397931 °	37.397931 °
				-120.972176 °	-120.972176 °
DWR ID	DWR_RD2063_53_t_2013_9				
Action/Comments					
Inspector Comments: The power source appeared to be safe and

View of the power sources for the pumping plant.

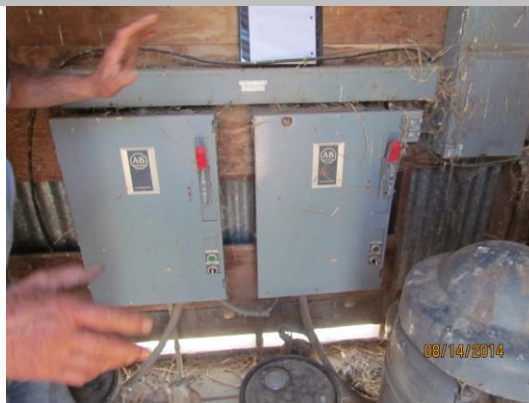
Photo 1 of 2 : ST_2014_RD2063_53_10_20140819_00016.jpg

LM Start	0.00	Rating **	A	Issue No.	10
LM End	0.00	Issue Type +	Ma	Location *	
Category	Pump Stations			GPS Latitude/Longitude	
				Start	End
Item	Pump Control Systems			37.397931 °	37.397931 °
				-120.972176 °	-120.972176 °
DWR ID	DWR_RD2063_53_t_2012_10				
Action/Comments					
Inspector Comments: Pump control systems were operational and in good condition.

View of the power control systems.

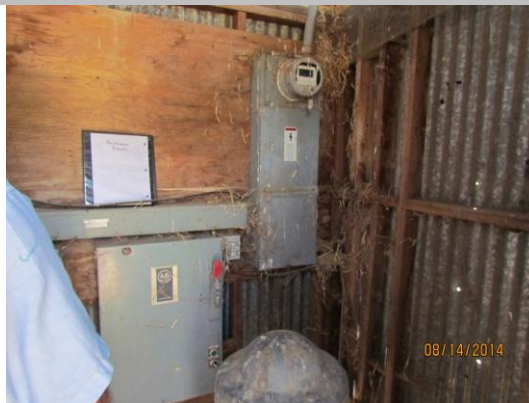
Photo 2 of 2 : ST_2014_RD2063_53_10_20140819_00017.jpg

View of the power meter inside the pumping plant.

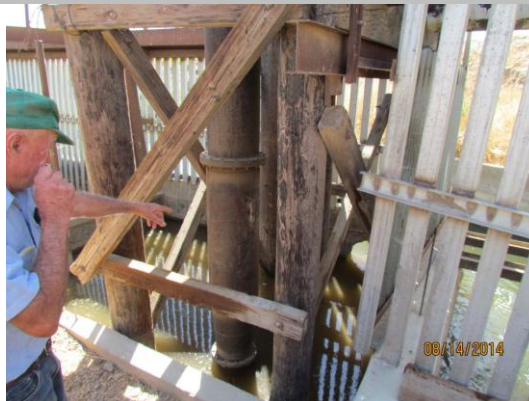
Photo 1 of 1 : ST_2014_RD2063_53_12_20140819_00019.jpg

LM Start	0.00	Rating **	A	Issue No.	12
LM End	0.00	Issue Type +	Ma	Location *	
Category	Pump Stations			GPS Latitude/Longitude	
				Start	End
Item	Sumps/Wet Well			37.397931 °	37.397931 °
				-120.972176 °	-120.972176 °
DWR ID	DWR_RD2063_53_t_2012_12				
Action/Comments					
Inspector Comments: The sump well was free of any debris.

View of sump well.

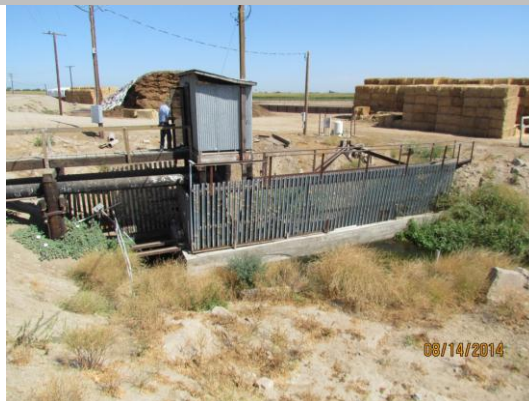
Photo 1 of 1 : ST_2014_RD2063_53_13_20140819_00020.jpg

LM Start	0.00	Rating **	A	Issue No.	13
LM End	0.00	Issue Type +	Ma	Location *	
Category	Pump Stations			GPS Latitude/Longitude	
				Start	End
Item	Trash Racks			37.397931 °	37.397931 °
				-120.972176 °	-120.972176 °
DWR ID	DWR_RD2063_53_t_2012_13				
Action/Comments					
Inspector Comments: The trash racks appears to be in good working condition.

View of the trash rack.

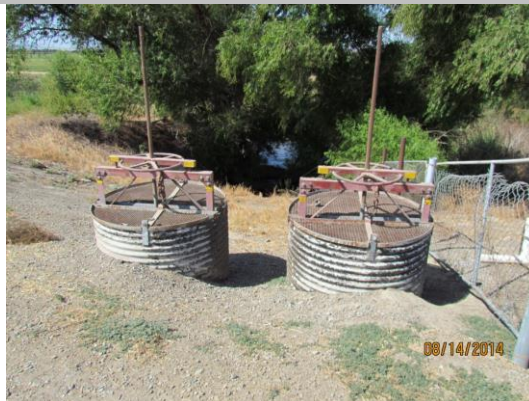
Photo 1 of 1 : ST_2014_RD2063_53_11_20140819_00018.jpg

LM Start	0.00	Rating **	A	Issue No.	11
LM End	0.00	Issue Type +	Ma	Location *	
Category	Pump Stations			GPS Latitude/Longitude	
				Start	End
Item	Sluice / Slide Gates			37.397931 °	37.397931 °
				-120.972176 °	-120.972176 °
DWR ID	DWR_RD2063_53_t_2012_11				
Action/Comments					
Inspector Comments: The slide gate appeared to be in working condition.

View of the slide gates at the pumping plant.

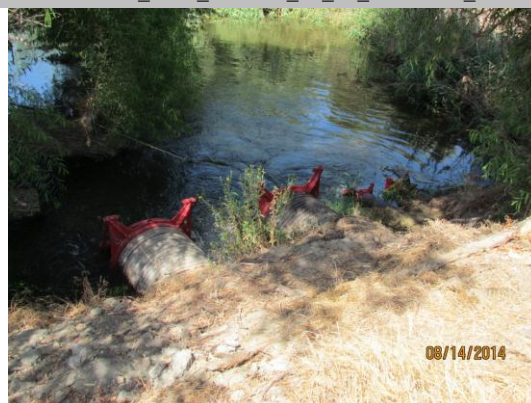
Photo 1 of 1 : ST_2014_RD2063_53_16_20140819_00021.jpg

LM Start	0.00	Rating **	A	Issue No.	16
LM End	0.00	Issue Type +	Ma	Location *	
Category	Pump Stations			GPS Latitude/Longitude	
				Start	End
Item	Flap Gates			37.397931 °	37.397931 °
				-120.972176 °	-120.972176 °
DWR ID	DWR_RD2063_53_t_2013_16				
Action/Comments					
Inspector Comments: Flap gates appeared to be in a good working condition.

View of the flap gates.

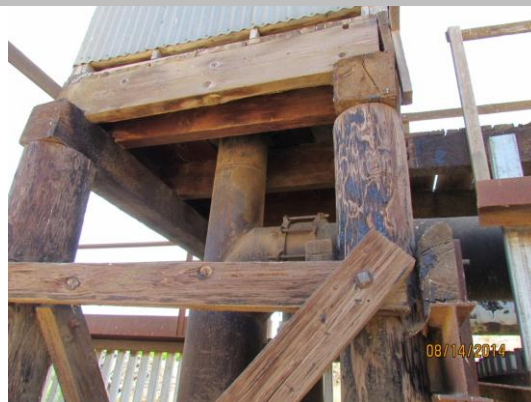
Photo 1 of 2 : ST_2014_RD2063_53_20_20140819_00022.jpg

LM Start	0.00	Rating **	A	Issue No.	20
LM End	0.00	Issue Type +	Ma	Location *	
Category	Pump Stations			GPS Latitude/Longitude	
				Start	End
Item	Intake and Discharge Pipes			37.397931 °	37.397931 °
				-120.972176 °	-120.972176 °
DWR ID	DWR_RD2063_53_t_2013_20				
Action/Comments					
Inspector Comments: The intake and discharge pipes appeared to be in good condition.

View of the intake pipe.

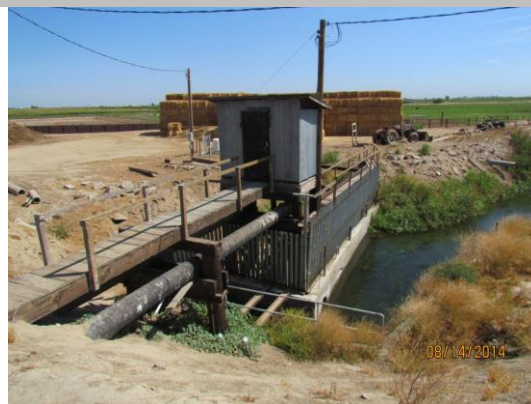
Photo 2 of 2 : ST_2014_RD2063_53_20_20140819_00024.jpg

Alternate view of the intake pipes.
